Aviation Risk Solutions Inc.Birchwood BCV AirportInspection Report

Inspection date 6/9/2014

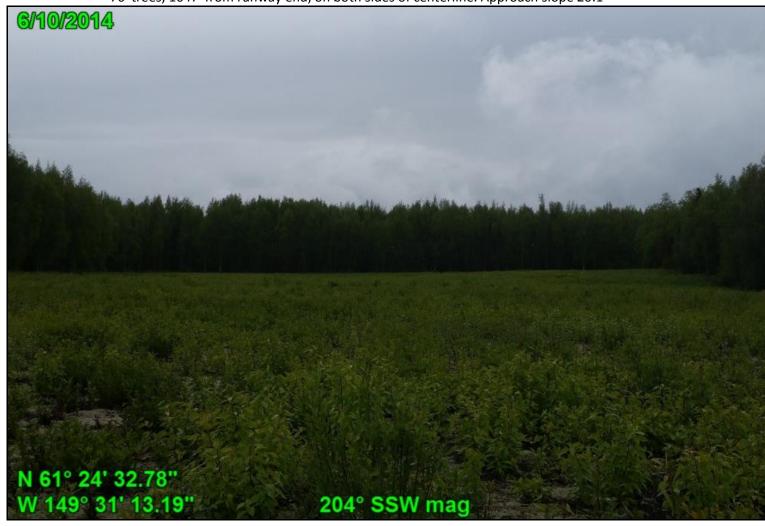
Runway 02L controlling obstruction

76' trees, 1647' from runway end, on both sides of centerline. Approach slope 20:1

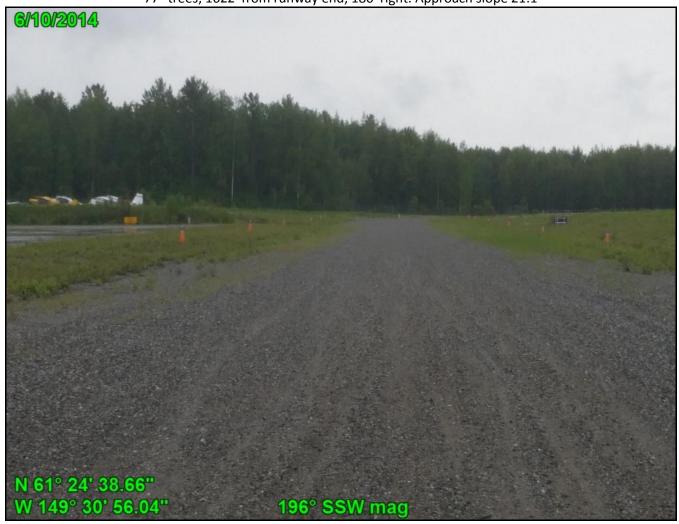
Runway 02R controlling obstruction.

77" trees, 1622' from runway end, 180' right. Approach slope 21:1

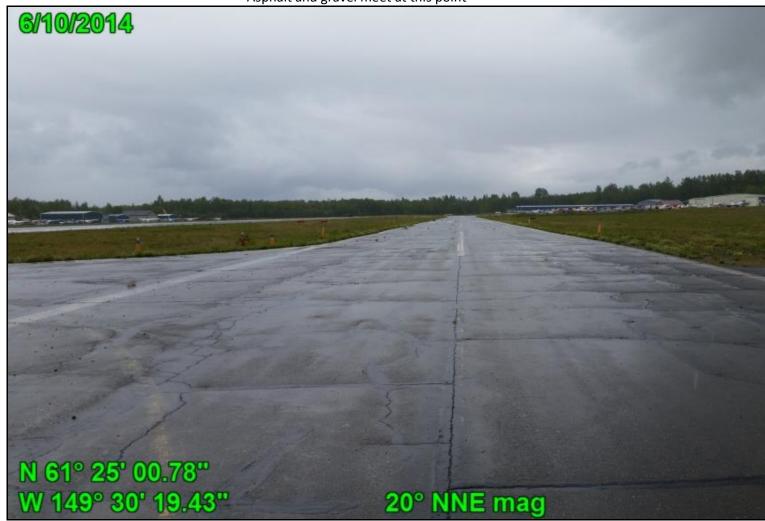
Runway 02R midfield

Asphalt and gravel meet at this point

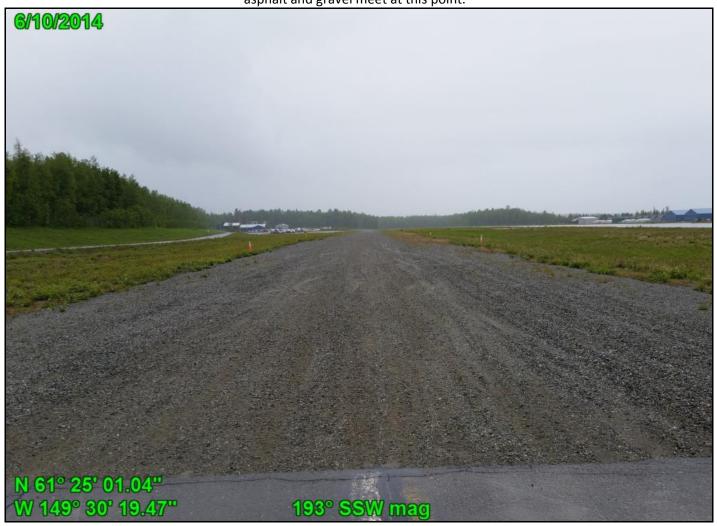
Runway 20L/02R midfield

asphalt and gravel meet at this point.

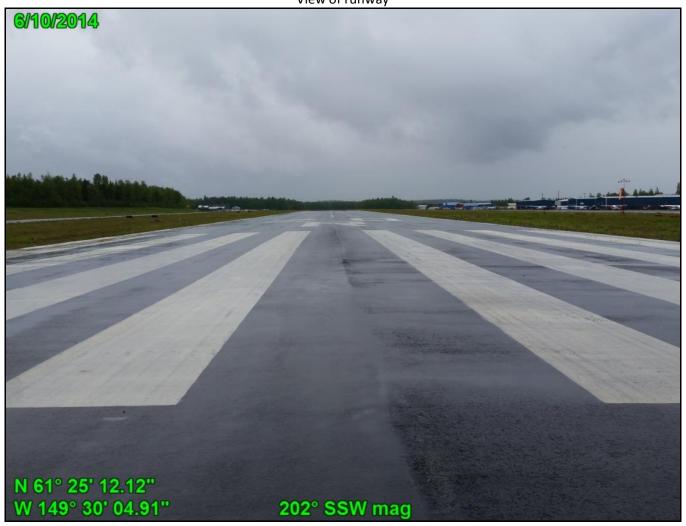
Runway 20R controlling obstruction

55' tree, 1112' from runway end, 120' right, approach slope 20:1

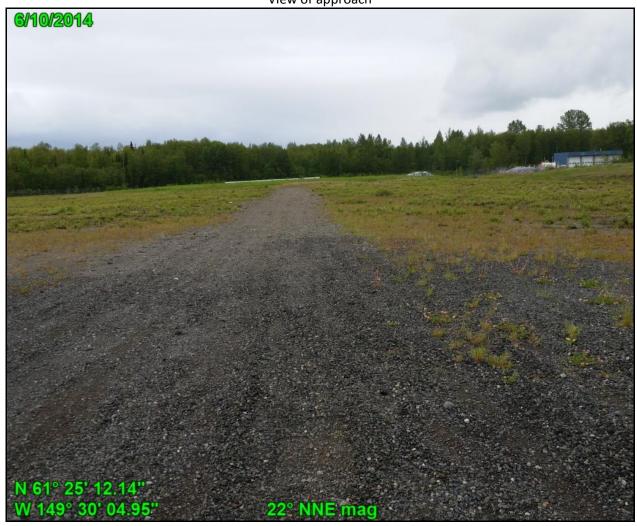
Runway 20R controlling obstruction

55' trees, 1112' from runway end, 120' left. Approach slope 20:1
